## REFRACTORY CASTABLES: THE TOP 20 MAIN FAILURES WITH REFRACTORY CASTABLES. Products, Diagnosis and Solutions.

April, 2026

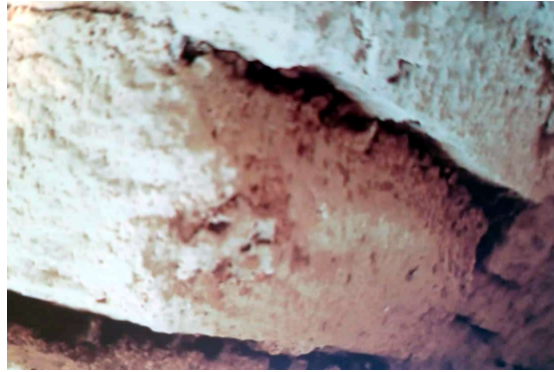
## 3) Pronounced wear at the joints of the panels or cast sections:

**Observation:** When a castable installation is done in panels, or rectangles that share a joint between them (as indicated by a correct installation); after a time of use it is observed that these joints become excessively widened promoting the general wear of the entire panel and forcing the equipment to be taken out of service for repair.

- Excessive linear variation of the selected product, which promotes high thermal expansion. This, combined with the stresses inherent in the oven as a whole, begins to wear down the edges of the joints, widening them over time.
- Incorrect installation of the product, causing defects in the joints upon removal of the formwork.

- ✓ Review the product selection, choosing the one that causes the least possible linear variation in this application.
- ✓ Review the entire product installation and convective drying process.
- ✓ Ensure that the formwork is well-made to guarantee regular joints, without deformation or misalignment.
- ✓ Consider the possibility of installing a compensating joint where appropriate (ceramic fiber).

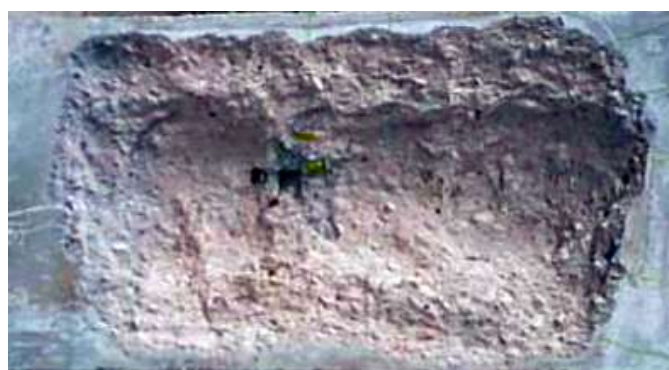
#### 4) Explosion inside refractory concrete:

**Observation:** A common problem, especially with thicker coatings made of dense or low-porosity materials (low cement, ultra-low cement, etc.), is the problem of partial or total blasting of the coating. Remember that the water contained in the coating, during heating (controlled or not), must travel through the entire applied thickness as steam and be expelled. If it cannot escape, either due to low porosity or because the heating rate is too high and generates much higher pressure steam, this pressure will cause the installed thickness to explode and destroy it.

- The materials are too dense and lack additives or binders that aid or accelerate the drying process (fiber-reinforced concrete, rapid-drying concrete).

- No method has been provided to channel water vapor through the installed thickness. Keep in mind that the insulating concrete (the outermost layer) has a water content that can be 3 to 10 times higher than that of the refractory material installed further down. A significant amount of water needs to be removed from the bottom.

- The drying method may have been too premature (not respecting at least 24-48 hours after concreting). There may be a significant amount of unset, or semi-liquid, material.

- The drying methods used may not accurately follow the drying curve recommended by the manufacturer. Excessive rapid heating will almost certainly cause an explosion. Special attention must be paid to the temperature range from 100°C to 220°C, as this is when water vapor is most concentrated.

- The amount of water added during the concrete mix must comply with the manufacturer's instructions. Less water will result in greater density (more resistance to steam). More water will generate more steam. Both situations are detrimental. Remember that the steam will continue to increase pressure until it overcomes the resistance of the coating. The greater this resistance, the greater the potential for an explosion.

- ✓ Use materials specifically designed for better or faster drying.
- ✓ Install steam outlet channels using thin plastic cords or other alternatives.
- ✓ Perform convective drying using external equipment capable of producing the appropriate drying curve for the coating. Drying through the gradual start-up of the equipment's burners or other improvised drying methods using wood or other combustible materials does not allow for the accurate and reliable production of a drying curve. These methods are not designed for such applications.

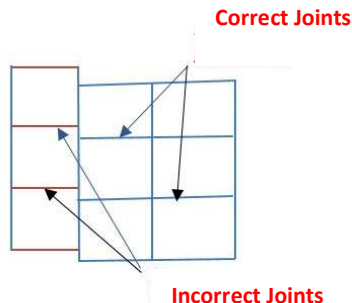
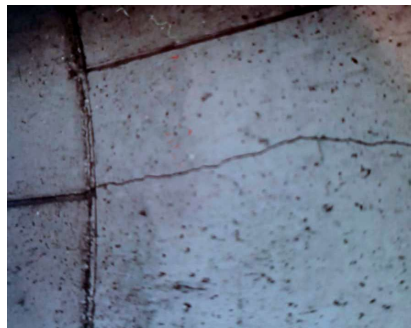
## 7) Cracks at joint corners:

**Observation:** Minimal cracks (less than 1 mm) are evident, which divide some panels almost always in the vicinity of the joints between them.

- Design and construction of the joints. The joints are misaligned, causing cracks..

- ✓ Preparation and design of the formwork to align joints between panels to be filled.

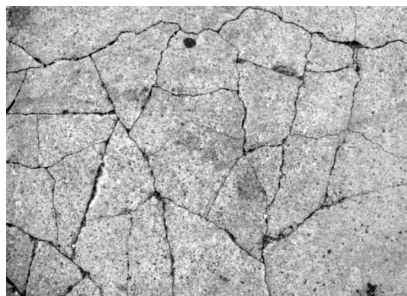
## 9) Cracking after setting:

**Observation:** It may happen that after pouring and subsequent setting, the surface, upon removal of the formwork, is found to be entirely, or partially, full of very thin cracks.

- Excess water in the mix.
- Calculation based on bags of material and not the exact weight of the mix (the bags are uneven).
- Incorrect material selection.
- Excessive mixing time.

- ✓ Follow the installation procedure for each product.
- ✓ Ensure that each batch is mixed with the correct percentage of water (measure the weight of the material in kilograms and the amount of water in kilograms).
- ✓ Do not overmix the material, i.e., do not overmix. This can make the mixture too fluid.

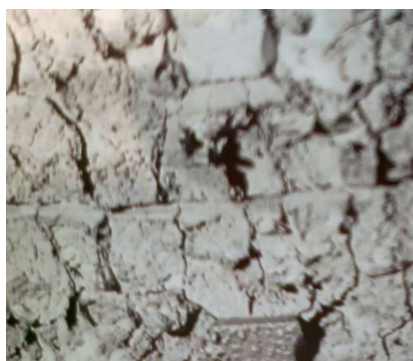
## 10) Shrinkage cracking:

**Observation:** After a certain period of use, the concrete surface is found to be covered with cracks that were not present during pouring and curing and appear after use. The cracks exhibit a classic quadriform pattern, typical of mechanical stress.

- Excessive heat input. The thermal expansion and contraction cause the refractory material to break into small pieces as it contracts.
- Incorrect concrete selection. It shrinks too much at that temperature.
- Kiln starting at too high a heating rate.

- ✓ Select another product. Choose one that exhibits slight shrinkage or remains neutral at the oven's actual operating temperature.
- ✓ Check if the oven's operating temperature matches the process specifications, or if there is an error, or if overheating occurred at any point.
- ✓ Follow the oven manufacturer's recommended start-up curve, or check if any process parameters have changed.

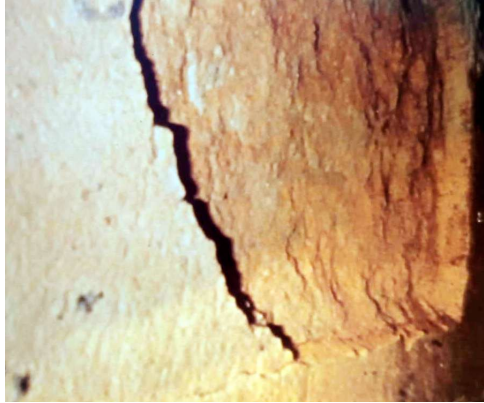
### 15) Layer lamination:

**Observation:** Luego del uso, se observan zonas importantes, de mayores profundidades que se han caído mientras las linderas están sin problemas. No son ni cráteres, ni desprendimientos superficiales.

- Time may have been taken between sections during installation by casting or injection. This prevents the entire surface from acting monolithically, as adhesion between sections is not optimal.
- The area to be covered may be too large, requiring multiple mixes and resulting in delays between mixes while the material sets.

- ✓ In these cases, first, it is necessary to divide the wall into panels (max 1-1.2 m<sup>2</sup> each) arranged in a line and proceed to fill them in a "checkerboard" pattern, that is, pouring or injecting panels alternately, and once those have set, filling the remaining unfinished panels.
- ✓ Implement convective drying.

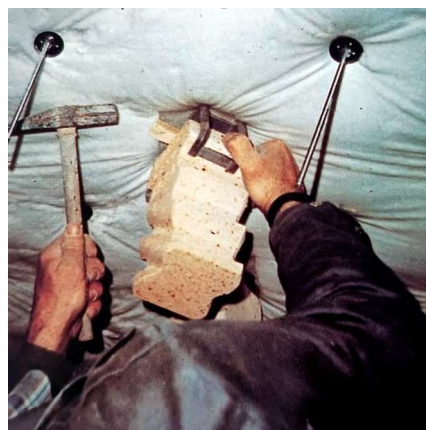
**16) Deformed and/or broken ceramic anchors:**

**Observation:** The ceramic anchors (usually called dummy anchors) are found broken, cracked, or missing a piece of the hot side. At first glance, these elements appear to have been subjected to a force greater than expected, causing them to break or fracture. This is due to mechanical stress.

- An unexpected explosion during kiln combustion (perhaps due to irregular combustion).
- That the anchors were accidentally struck before use. Remember, these are ceramic pieces.
- That their installation and design are incorrect.
- That they cannot withstand thermal shock during kiln operation.

- ✓ Check the kiln for explosions or incomplete combustion, and ensure the packaging shows no signs of accidental drops or impacts.
- ✓ The installation design should allow for some movement of the anchor (at the top, via the fasteners), ensuring they are free within the concrete. The top of the anchor is often wrapped, approximately halfway, with ceramic fiber insulation. This improves the anchor's movement and enhances its resistance to thermal shock.
- ✓ Selecting the highest quality ceramic anchors is crucial.

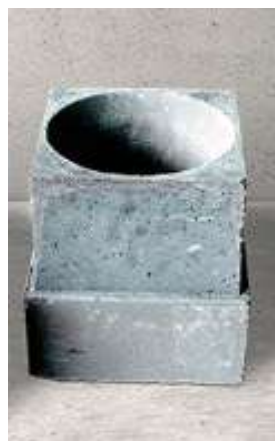
## 18) Desgastes prematuros en zonas cercana a la llama:

**Observation:** After a short time, a reduction in the refractory profile of the furnace burners becomes visible, indicating wear from flame erosion or dust swirling around the flame zone. This will necessitate replacing the burner block and risks further deterioration of the burner itself, reducing its lifespan.

- The burner block is of inadequate quality (material, drying or firing process, manufacturing procedure, etc.).
- The block is incorrectly anchored to the furnace and allows movement.
- There is a problem in the firing system causing unexpected explosions or vibrations.

- ✓ Castable selection: It must withstand high thermal shock stresses (medium alumina, low cement, cement-free). The type of raw material used is important.
- ✓ Check the anchoring system. It must be securely fastened and have an appropriate expansion joint to allow for minimal readjustment.
- ✓ Check the proper functioning of the fire suppression system.
